News from the Diesel & Electric Preservation Group

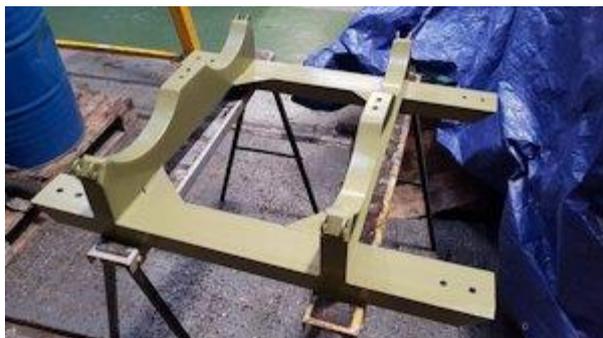
Air receiver support frame from D9518

D9518: Good progress is being made on this loco as can be seen from the attached photos that have been provided by Martin. The corroded electrical junction box has been repaired and is now ready for painting. The compressor is being stripped down so that a full inspection can be undertaken and repairs arranged as necessary. The air receiver support frame is one of many items that needs attention on this loco.

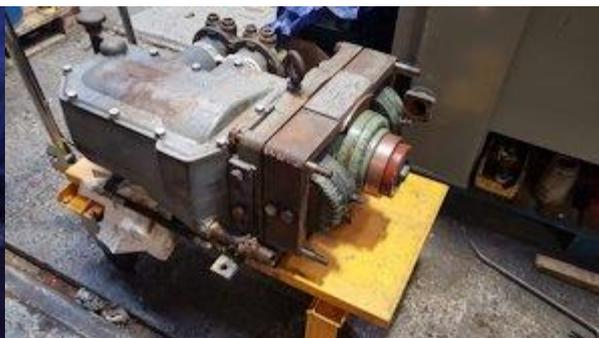
D9518's Compressor being stripped down

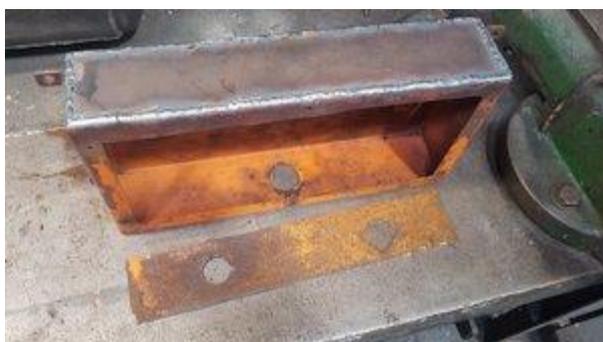
D9518 Electrical repairs

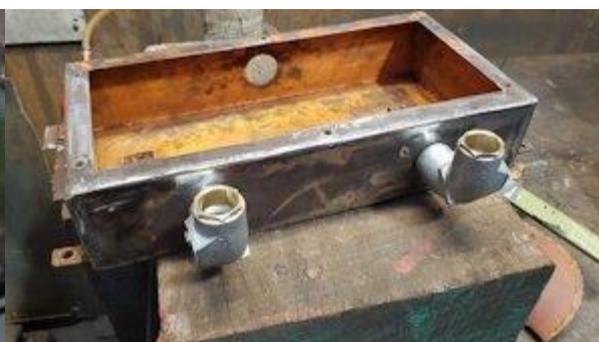
D9518 electrical repairs

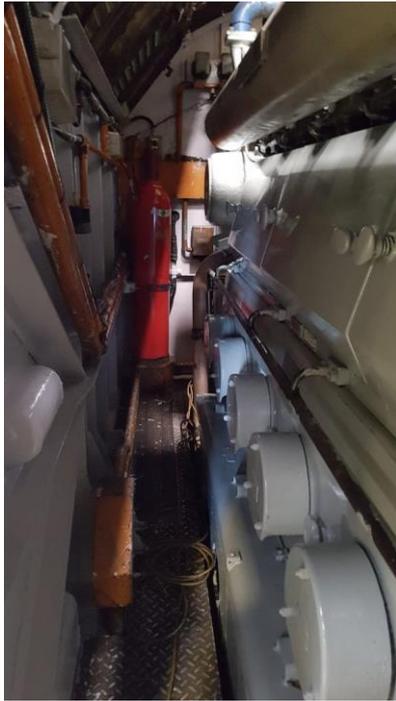
D1661 "North Star" (47077): Work continues on the internal cleaning and painting, and the attached photo (provided by Martin) shows the progress. Previously, the only colours visible in the engine room were light black and dark black!
